Manhole Inspection Summary

Manhole # S21E1_006MH

Insp Date: **5/23/08 9:30 AM**

Location Address: **2521 huron-puget alley**

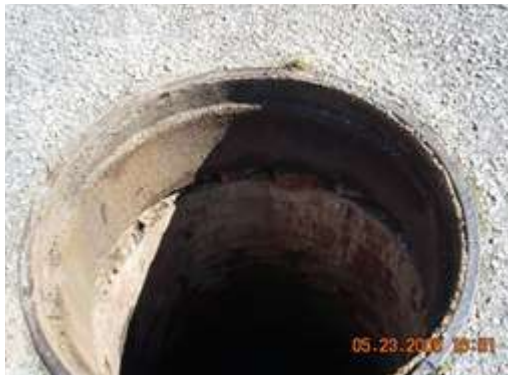
Misc. Defect 2

Subject To Ponding: **Sheeting**

inflow evidence from sheeting

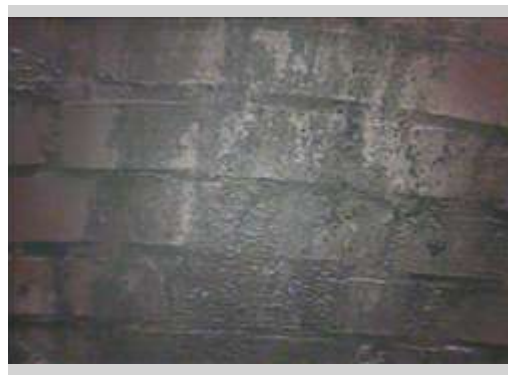
Defect 3

Infiltration: ☐ None ☐ Joint ☐ Cracks ☐ Mortar ☐ Roots ☒ **Wall**

infiltration @ barrel wall

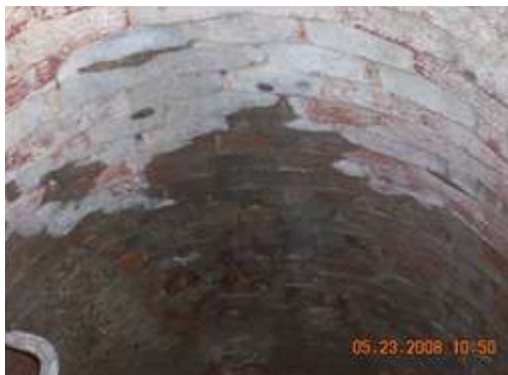
Defect 1

Infiltration: ☐ None ☐ Joint ☐ Cracks ☐ Mortar ☐ Roots ☒ **Wall**

infiltration @ corbel wall

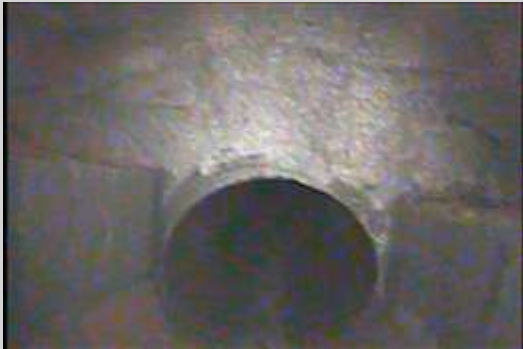
12 O'Clock Outflow

8 in. Circular Gravity Sewer
Pipe Out @ 12 O'Clock

Pipe Height: **8.4** (in.) Rod and Bar (Angled)
Pipe Material: **Clay** ☐ Pipe Lined
Invert Depth: **9.50** (ft.) Flow Characteristics: **Slow**
Deposits: ☒ None ☐ Mud ☐ Sludge ☐ Debris ☐ Grease
Silt Depth: **0** (in.) Deposits Extent:
Infiltration: **None** Pipe Seal Cond: **Sound**

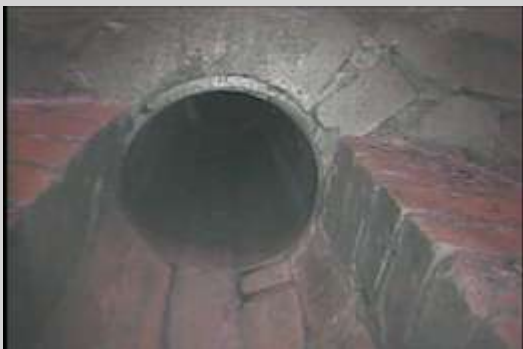
6 O'Clock Inflow

8 in. Circular Gravity Sewer
Pipe In @ 6 O'Clock

Pipe Height: **8.4** (in.) Rod and Bar (Angled)
Pipe Material: **Clay** ☐ Pipe Lined
Invert Depth: **8.90** (ft.) Flow Characteristics: **Slow**
Deposits: ☒ None ☐ Mud ☐ Sludge ☐ Debris ☐ Grease
Silt Depth: **0** (in.) Deposits Extent:
Infiltration: **None** Pipe Seal Cond: **Sound**
